Case 1. Ulterra motor does not turn on when the Power button on the control panel is pressed and released. The green “System Ready” and red “Status” LEDs do not light up.

Case 2. Ulterra motor green “System Ready” and red “Status” LEDs come on when the Power button is pressed but immediately go off when the Power button is released.

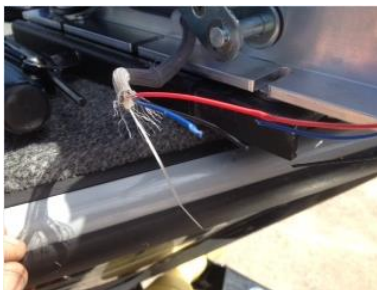
Figure 1: Actual photo supplied by a service provider.

Possible Cause 2: This malfunction is often found to be a result of unintentional/accidental damage to one or more of the three wires that connect each of the three Hall Effect Ulterra motor sensors to the main control board. The red, blue, and black wires going to each sensor are enclosed in black or gray mesh tubing running along both sides of the motor base extrusion. These wires can be accidentally damaged, pinched, or cut if care is not used to make certain that the motor (or Quick Release Plate)

mounting bolts do not damage the wires when the bolts are tightened. The cutting of any of the sensor wires will cause the motor to be inoperative.

Corrective Action: Contact your local Minn Kota service provider for an evaluation.
